Coil Cleaning: MYTHS AND MISREPRESENTATION

When you discover severely restricted air flow through a coil during normal service, it may be time to suggest a replacement, since attempting to clean such a coil may only make matters worse.

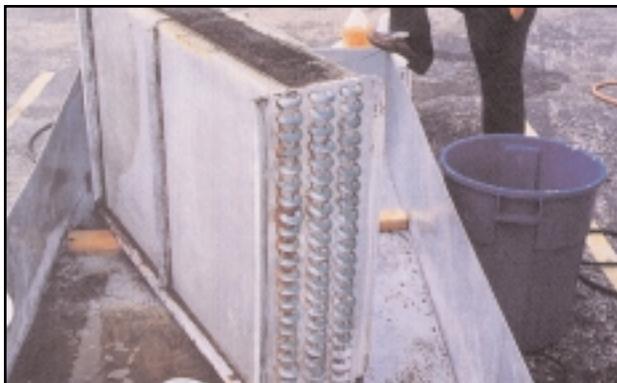
When this coil was removed from service, an interior packed with dirt and grime was revealed, despite hours of cleaning effort.

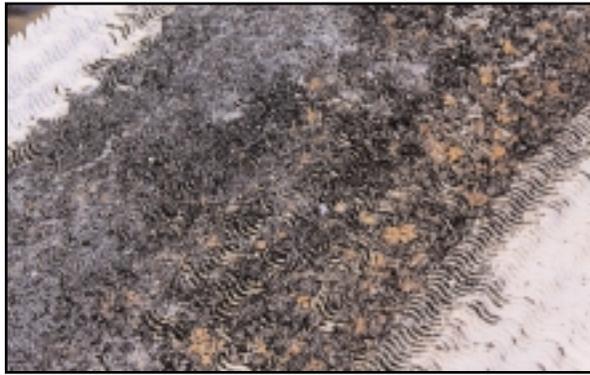
Full-strength coil cleaner applied to the surface of cooling coils then flushed with high-pressure hot water will result in a coil that appears to be clean, but may actually be a hotbed for microbial growth. Increased pressure drop and reduced air volume through such coils is a red flag that says it's time for a replacement.

Based on the above, and our hands-on coil cleaning experience, if your calculated pressure loss for a cooling coil that's over four rows in thickness is in excess of 1.5 to 3 times the factory ratings, it's time to consider a coil change. Why? Simply because you're not going to get that coil clean with presently known cleaning procedures.
